Auftraggeber / Auftrag
TSK a.s
Vyšehradský Bridge
Prague

waltgalmarini
with COWI

Design Concept of the Footbridges V-025 and V-026

17. June 2021

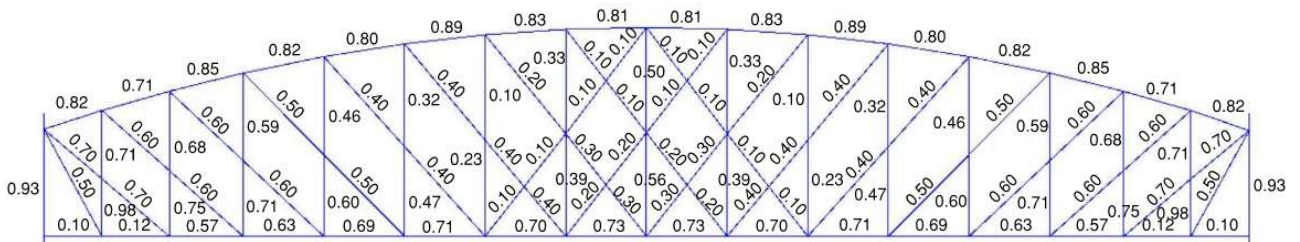
Fig. 5: ULS utilization for two LM71 trains at midspan plus pedestrian live load, with a 15% corrosion allowance.

Checking the structural members at the Ultimate Limit State (ULS) reveals that the main truss members are acceptable, with strength utilization factors all less than 1.00. This is assuming a uniform 15% loss of section throughout due to corrosion.

Fig. 5 shows the calculated ULS utilization ratios in the truss for the load case with two LM71 trains passing at midspan plus associated full pedestrian live load.

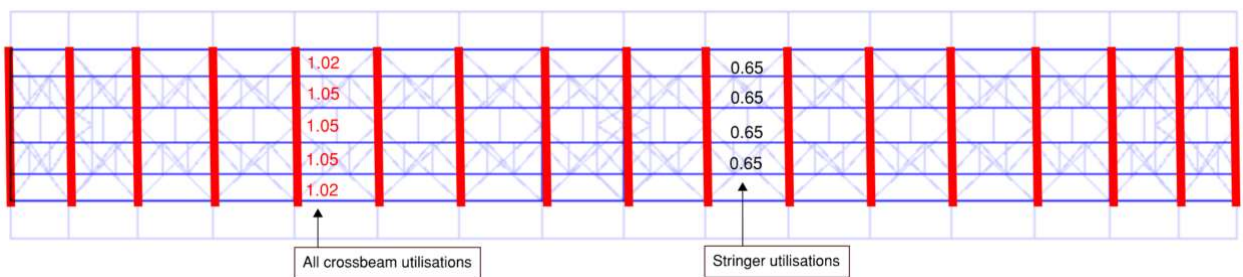
Fig. 6: Summary of ULS utilization for the crossbeams and stringers, with a 15% corrosion allowance.

The railway stringers are also found to be acceptable at ULS, but a relatively small overstress is identified in the crossbeams which form the bottom transverse member of every crossframe.

Fig. 6 shows the worst case results for the crossbeams and longitudinal rail stringers. These are governed by local loads applied from the heavy bogies of the LM71 trains, so the stress levels are the same everywhere, with slight reductions in the end bays where the transverse frame spacing reduces slightly. The crossbeams are slightly overloaded in every case, assuming a 15% loss of section due to corrosion.

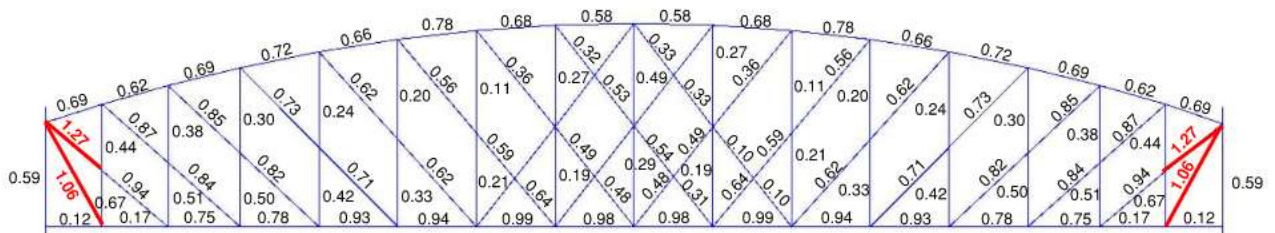
Fig. 7: Fatigue stress threshold utilizations in the main truss, assuming a 15% corrosion allowance.

This shows that under the cyclic loading model assumed in the analysis, the diagonal bracing members at the end of the bridge experience cyclic stress levels higher than the threshold level above which some fatigue damage accumulation can occur. The critical section is the reduced net cross section in the parent plate through the rivet holes. The parent plate in these areas is covered by the riveted cover plates, so if any fatigue cracking is occurring it may not be visible to inspection.

Calculated stresses in the main truss members are acceptable at the ultimate limit state, with utilization ratios less than 1.00 everywhere, but the diagonal bracing members nearest to the ends of each span are found to fail the fatigue assessment criteria adopted for this study.

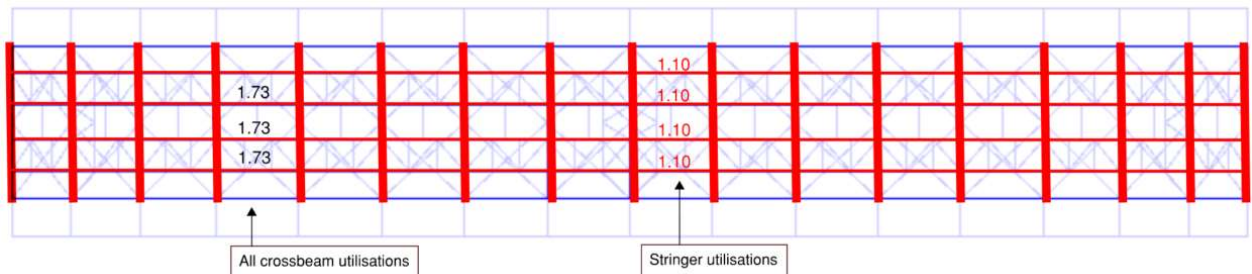
Fig. 8: Fatigue stress threshold utilizations for the crossbeams and stringers, assuming a 15% corrosion allowance.

Fig. 8 shows the worst case utilizations derived from the fatigue analysis for the crossbeams and longitudinal rail stringers. These are subject to local loading from the train axles, and are consequently bound to be the elements in the bridge most susceptible to potential fatigue damage.

This analysis reveals high levels of potential overstress in the crossbeams, indicating a high likelihood that some fatigue damage accumulation is occurring in these members. Again, as before, the worst potential damage is predicted to occur in the parent plate at the position of the rivet holes. These areas are covered by cover plates making it very difficult to inspect the parent plate to detect cracks that may be occurring there.

The main railway stringers and cross beams supporting the tracks experience significantly high fluctuating fatigue stresses under railway loading. The stress levels exceed the threshold below which fatigue damage is considered unlikely in a 120 year old steel structure, so it is likely that fatigue damage is occurring. It is to be expected that close inspection would reveal that fatigue cracking is already evident in these areas.

The inference is that all the crossbeams and longitudinal railway stringers should be replaced. This can be done one bay at a time to minimise disruption to the railway, as described in Section 7 below.

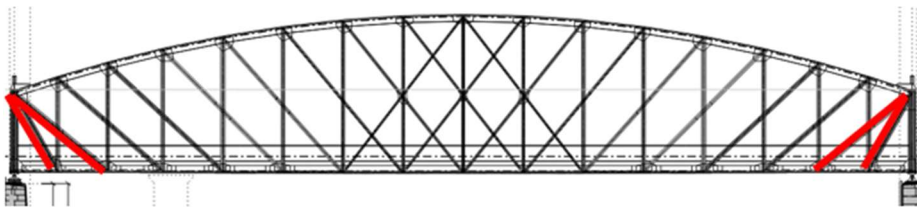
Fig. 21: Diagonal bracing members with potential fatigue damage requiring further investigation.

We have however identified a potential fatigue problem in the diagonal members closest to the ends of the bridge. These members are indicated in Fig. 21. The assessment has shown that calculated fatigue stresses in these members exceed the threshold stress range above which fatigue damage can be expected to occur. However, this is based on a relatively conservative fatigue loading assumption. It is recommended that further investigation is carried out, including detailed on-site inspection to check for visible signs of fatigue damage, before concluding whether or not these elements need strengthening or replacement.

If it is concluded that these diagonals need replacement, it would be necessary to provide an alternative load path to carry the shear while the work is carried out. This is considered in the next section.

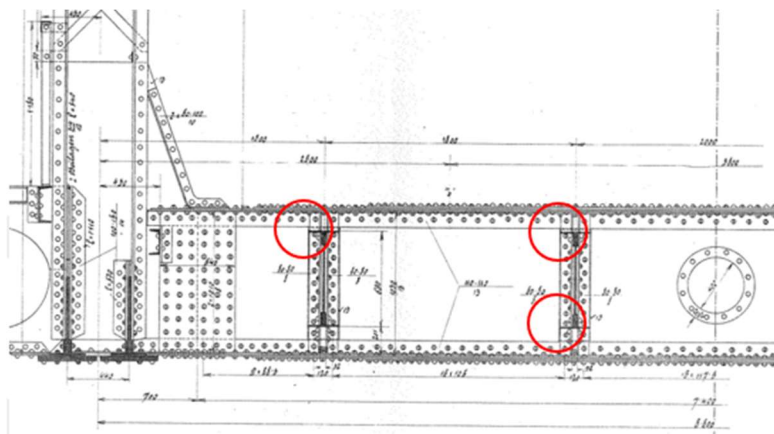
Fig. 22: Rail stringer to crossbeam joints most prone to potential fatigue damage.

The biggest potential problem experienced by the bridge affects the crossbeams and longitudinal stringers supporting the railway. It is no surprise that these areas are subject to the highest potential fatigue damage due to the passage of the trains. The fluctuating local stresses occurring in certain joints between the rail stringers and the crossbeams due to the passage of trains are high enough to cause fatigue damage. The details worst affected are indicated in Fig. 22. The crossbeams are also found to experience high stresses which result in marginal overstressing in the section at ULS.

Further investigation is needed to ascertain the level of fatigue damage that may already have occurred and to establish the best solution for their repair or replacement. It is also important to establish more accurately what loss of section due to corrosion should be applied. Nevertheless, it seems probable that some or all of the crossbeams and stringers will need to be replaced and an outline of the replacement method is given in the next section. Replacement is likely to be a much quicker, simpler, less disruptive and more durable solution than attempting to repair and strengthen the existing members in-situ.
