Auftraggeber / Auftrag
TSK a.s
Vyšehradský Bridge
Prague

waltgalmarini
with COWI

Design Concept of the Footbridges V-025 and V-026

17. June 2021

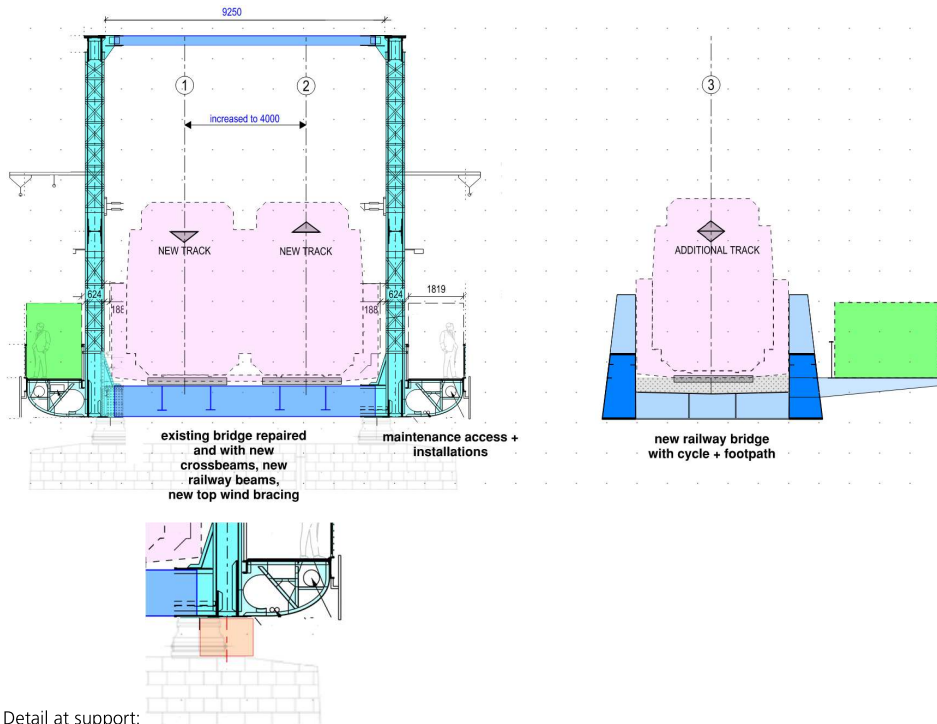
Fig. 14: Option 2 + 1c. Cross-section and detail at support.

Replacing the entire bridge deck, the wind bracing and the portal frames is a massive intervention on the historical substance. Historically, the elements that are to be replaced in this option are also the elements, that have been worked on already (interventions 1969) and that, at least for the longitudinal stringers under the rails, can be viewed as wear part.

To allow for a larger clearance (both between track and longitudinal truss and between the tracks themselves) and to thereby improve the operational safety of the railway it would be necessary to replace the existing crossbeams and railway beams as well as the top wind bracing, see Fig. 14. Large parts of the portal frames at the span ends will also have to be replaced. Contrary to the rehabilitation discussed in the next chapter, this cannot be done in-situ under traffic. The lateral truss girders need to be entirely separated from the connecting horizontal elements. This can be done either by lifting a span off its position and float it to an installation area nearby or by the installation of a working platform under the existing bridge. Either way, the moved bridge superstructure and in particular the supports will not align with the piers as originally. This will require a modification of the piers or at least of the pier top. This solution has been chosen recently as a compromise between heritage and railway considerations for the Weissbad crossing, a riveted truss bridge of similar age and condition but with a far smaller scale.

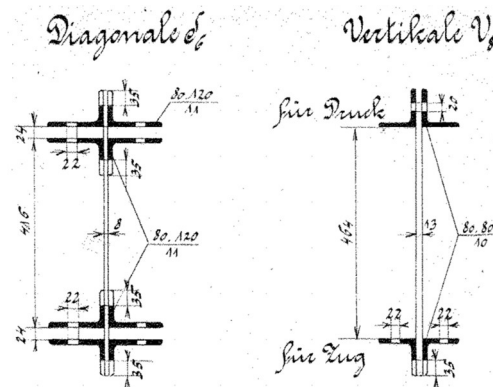
Fig. 26: Typical built-up sections of main truss diagonal (left) and post (right).

Local corrosion might lead to a local capacity reduction that requires remedial measures. As the truss members are composed of multiple components, see examples in Fig. 26, it will often be sufficient to apply measures on a specific component rather than on the entire member. As such it will often be enough to stabilise the remaining components by temporary measures while replacing or strengthening the component or sections of it.

Replacing of a section of a component of riveted bridges is a procedure that is done frequently throughout the world. From a heritage point of view an important question is whether rivets are replaced by fitting bolts or rivets. While the traditional knowhow of riveting might be lost in many parts of the world, automatic machines have been developed recently, such that riveting is a real possibility again. It is to be noted though that riveting is substantially more costly.

Strengthening of a component can often be done efficiently by the addition of plated steel elements. Again, the main challenge is the bolting or riveting of the new element to the existing components. For the short-term temporary state where the existing rivets are removed temporary stabilising measures as described previously can be required.
